CONNECTICUT RIVER BASIN
WINCHENDON, MASSACHUSETTS

WHITNEY POND
MA 00633

PHASE I INSPECTION REPORT
NATIONAL DAM INSPECTION PROGRAM

MARCH 1979

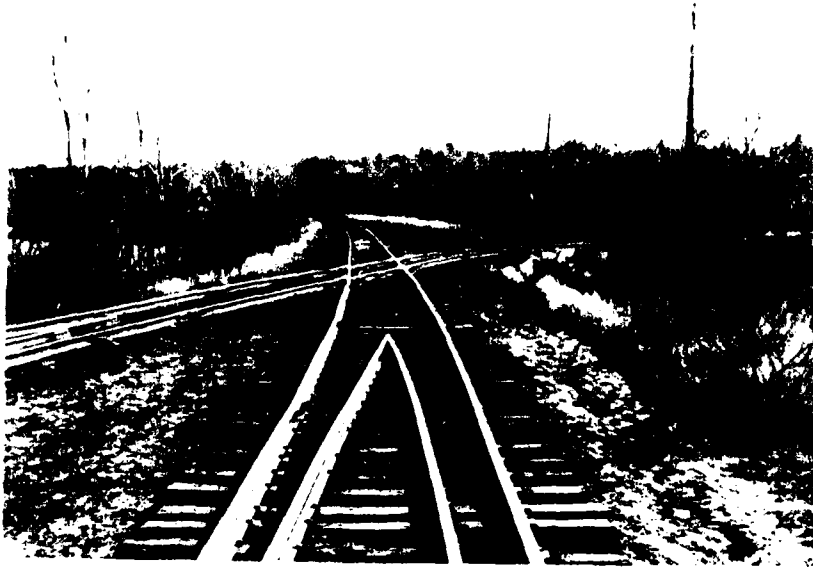
PHOTO NO. 1 - Crest of dam viewed from left abutment of railroad bridge.

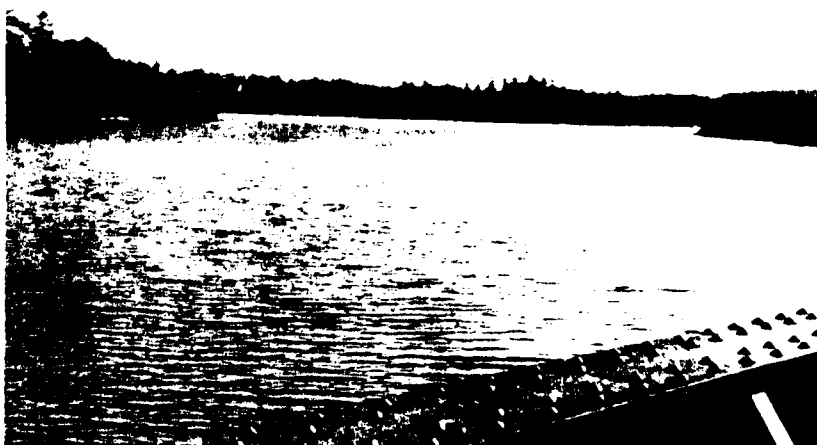
PHOTO NO. 4 - Upstream view from railroad structure.
